Optical Hazing on Polished Porcelain Tiles

By Bill Griese

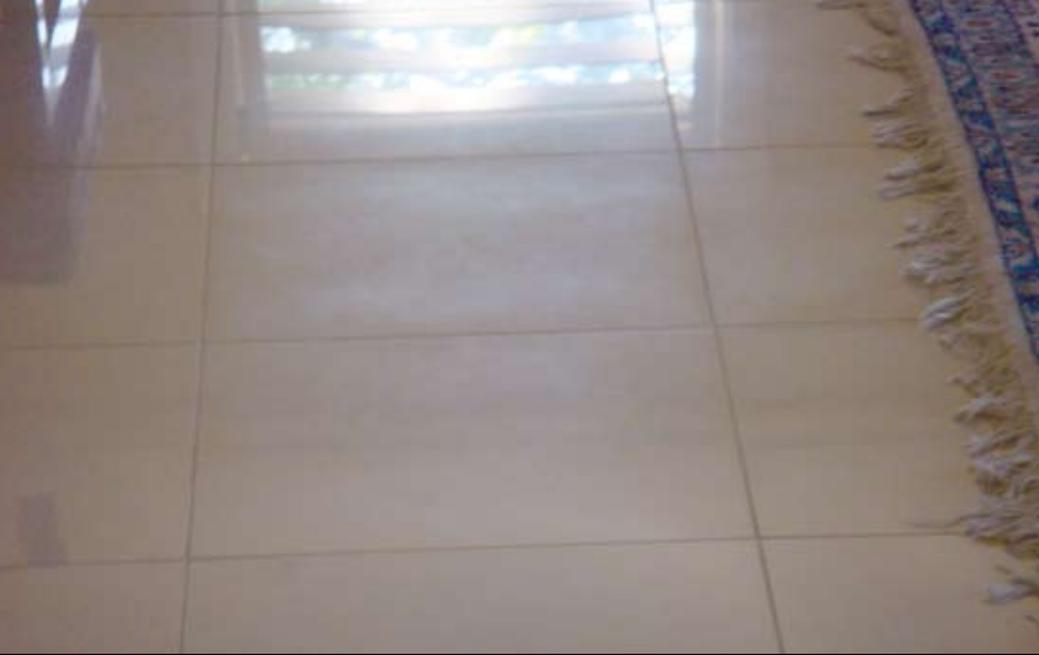
Non-uniform polishing can result in alternating bands of reflective and non-reflective regions on a polished tile’s surface.

In most cases, hazing effects can either be attributed to the polishing procedures or the quality of the materials being polished. North American and European factories have developed proprietary procedures to produce uniformly consistent and high quality polished surfaces with sliding head polishing machines. These machines incorporate a transverse oscillating motion to increase overall uniformity. Polishing materials, machine main-

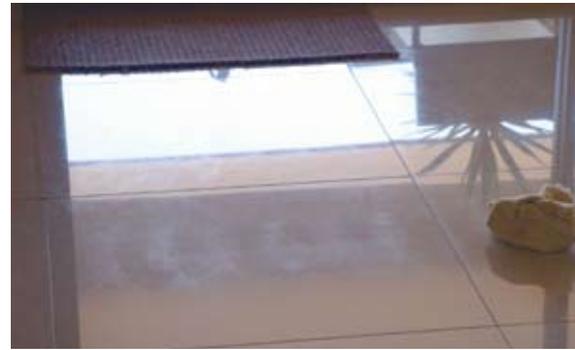
Top Right: When illuminated by light coming in from the side at a low angle, cloudy non-reflective spots might be observed.

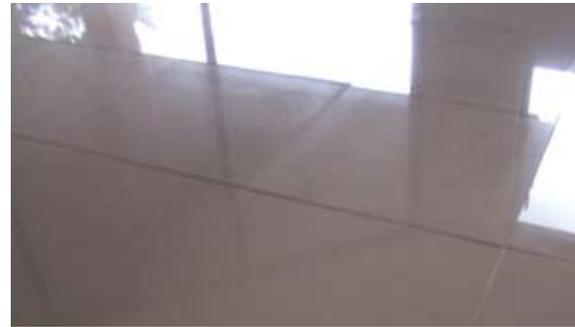
Bottom Right: Optical hazing can also result in a distorted, non mirror-like reflected image.
